The characterisation of next generation ceramic bearings for orthopaedic hip applications

Insley, Gerard M.

For the degree of PhD

At the University of Bath

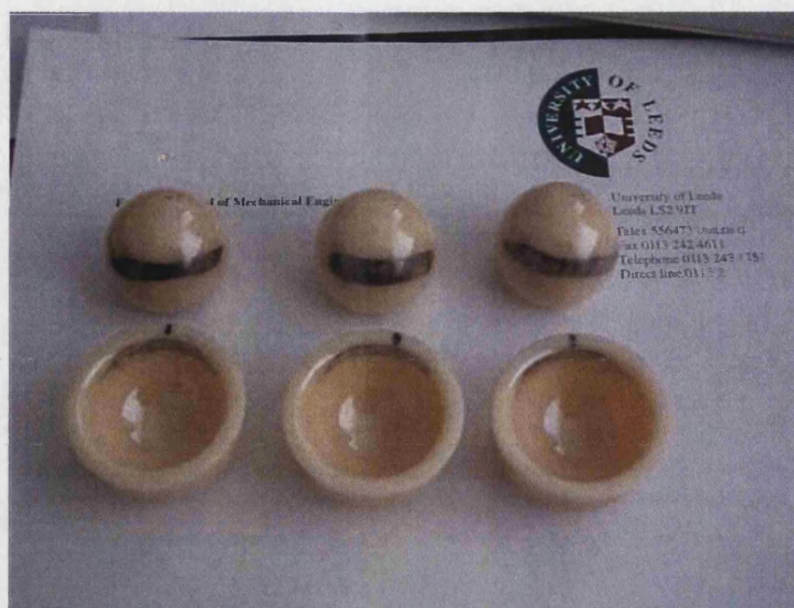
Figure 68a: Wear stripes on the CAL/CAL components after 5 million cycles.

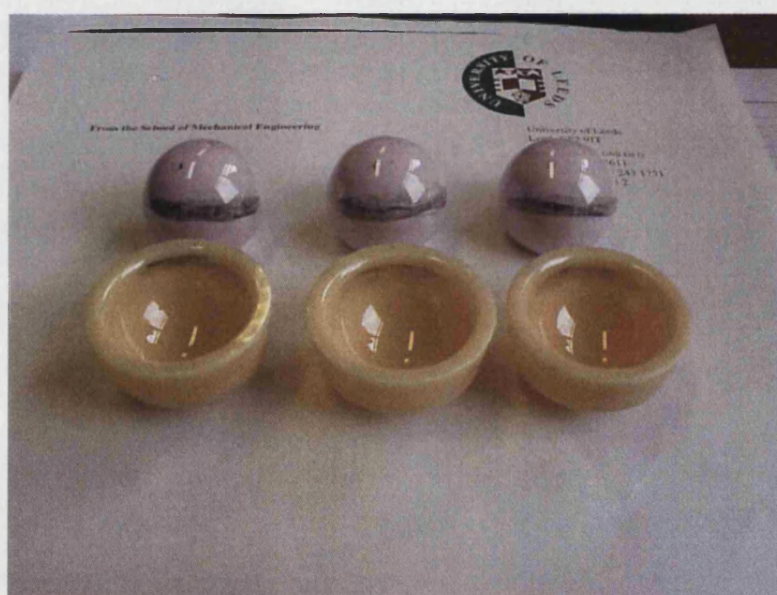
Figure 68 b: Wear stripes on the CZTA/CAL components after 5 million cycles.

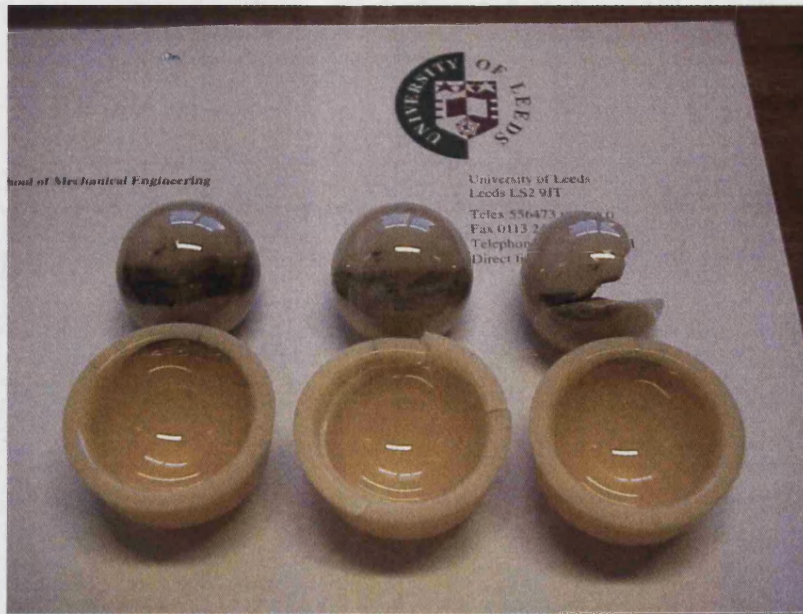
Figure 79a: Wear stripes on the NZR/CAL components after 5 million cycles.

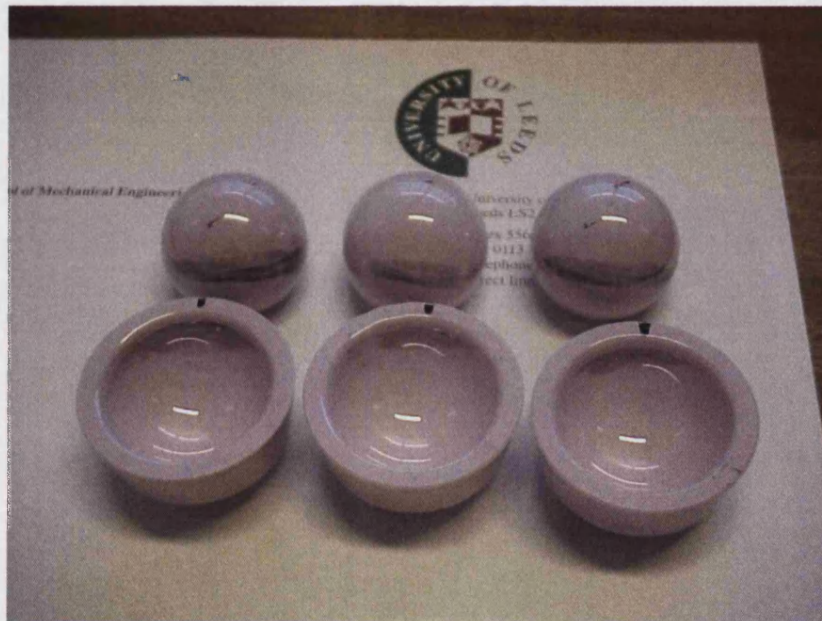
Figure 79 b: Wear stripes on the CZTA/CZTA components after 5 million cycles.
